Manhole Inspection Summary

Manhole # S39CC1008MH

Insp Date: **12/12/06 9:40 AM**

Location Address: **750 MCKEWIN AVE**

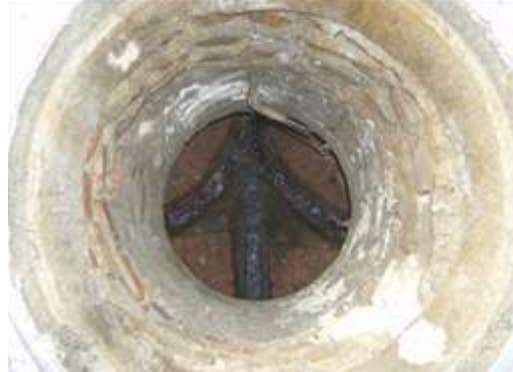
Top View

Corroded and missing steps. Bench and Channel debris.

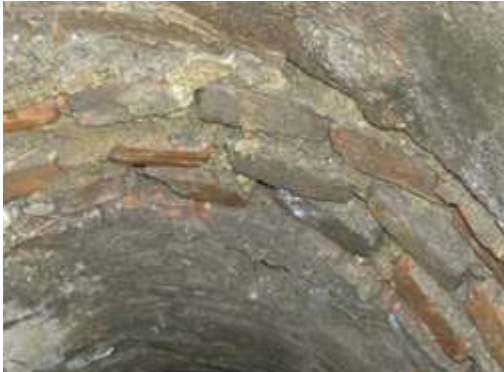
Defect

Frame leaks. Adjustment and Corbel deterioration and infiltration.

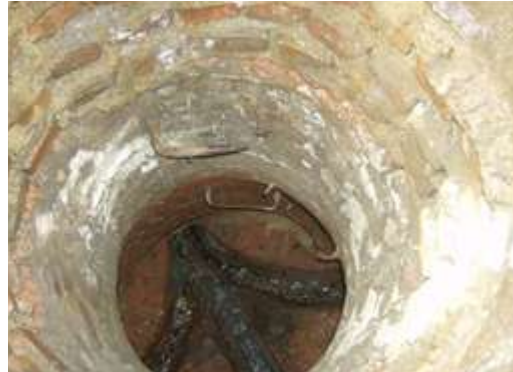
Defect

Frame leaks. Adjustment and Corbel deterioration and infiltration. Barrel infiltration.

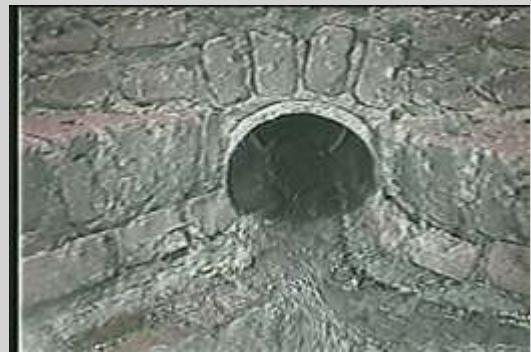
Pipe Out @ 12 O'Clock

Rod and Bar (Angled)

Pipe Material: **Clay** ☐ Pipe Lined

Invert Depth: **9.49** (ft.) Flow Characteristics: **Slow**

Infiltration: **None** Pipe Seal Cond: **Sound**

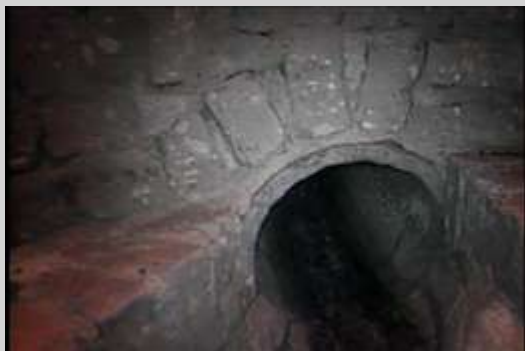
Pipe In @ 3 O'Clock

Rod and Bar (Angled)

Pipe Material: **Clay** ☐ Pipe Lined

Invert Depth: **9.34** (ft.) Flow Characteristics: **Slow**

Infiltration: **None** Pipe Seal Cond: **Sound**

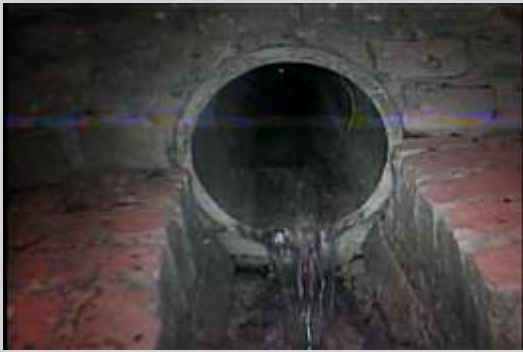
Pipe In @ 6 O'Clock

Rod and Bar (Angled)

Pipe Material: **Clay** ☐ Pipe Lined

Invert Depth: **8.81** (ft.) Flow Characteristics: **Slow**

Infiltration: **None** Pipe Seal Cond: **Sound**

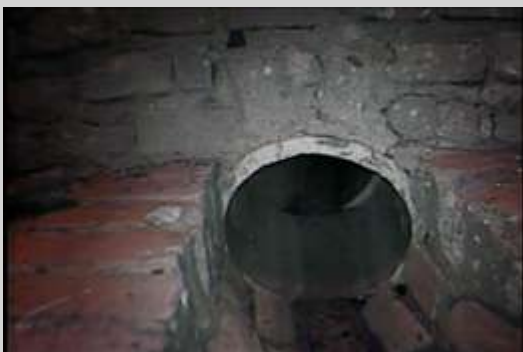
Pipe In @ 9 O'Clock

Rod and Bar (Angled)

Pipe Material: **Clay** ☐ Pipe Lined

Invert Depth: **9.26** (ft.) Flow Characteristics: **Slow**

Infiltration: **None** Pipe Seal Cond: **Sound**
